Performance of Horizontal Infrastructure in Christchurch City through the 2010-2011 Canterbury Earthquake Sequence

March 2014

Summary

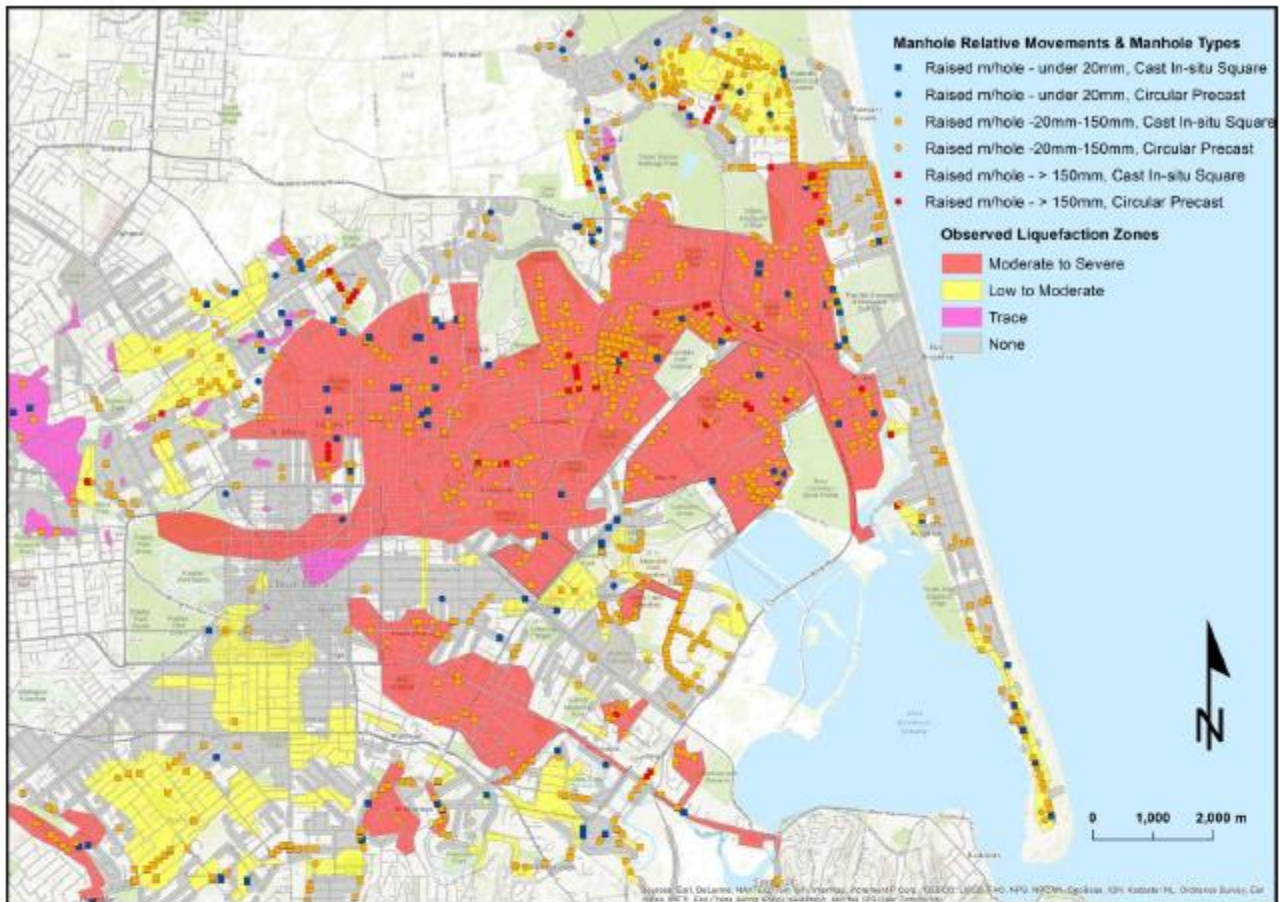
clear relation between liquefaction severity and damage to the potable water and wastewater pipe network (Cubrinovski, et al., 2011). Here, the liquefaction severity maps of Cubrinovski et al. (2011) were used in combination with manhole characteristics and damage observations to identify mechanisms causing relative displacements of manholes. The combined information is presented as a map in Figure 1.

Figure 1: Map of Christchurch showing liquefaction severity, manhole location and relative displacements. Modified from (Cubrinovski & Taylor, 2011) and (McNeill & English, 2011).

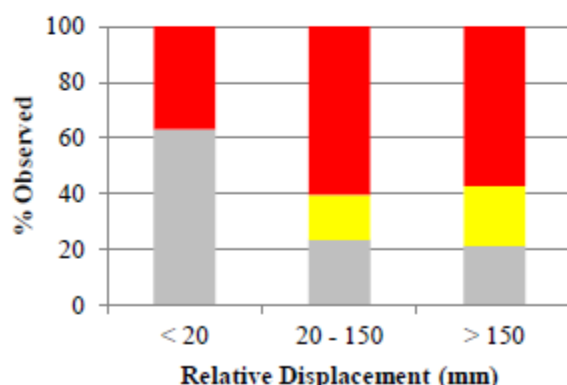
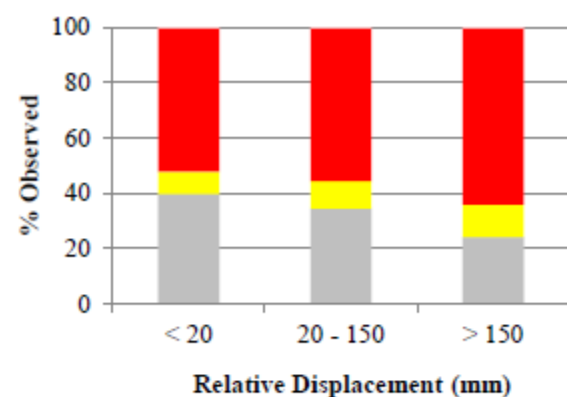
Figure 4 a) shows the percentages of each relative displacement category due to liquefaction severity for circular manholes, and Figure 4 b) shows the percentages of manholes in each relative displacement category due to liquefaction severity for square manholes. For the circular manholes with low relative displacement (< 20 mm), 63% were in areas of no liquefaction, and 37% of the manholes with the same low relative displacements were in areas of moderate to severe liquefaction (Figure 4 a)). The result that a higher percentage of manholes exhibiting low relative displacements were in areas of no liquefaction is expected. At the other extreme of the relative displacement scale, the highest percentage (57%) of manholes exhibiting high relative displacements (> 150 mm) were in areas of moderate to severe liquefaction. This is also expected, as severe liquefaction is expected to be more damaging to structures in and above the ground. 21% of the manholes with the same high relative displacements were in areas of no liquefaction.

Figure 4 a) and b): Relationship between relative displacement and liquefaction severity for a) circular manholes and b) square manholes

For the square manholes with low relative displacement, 40% were in areas of no liquefaction, and 52% of the manholes with the same low relative displacements were in areas of moderate to severe liquefaction (Figure 4 b)). The result that a lower percentage of manholes exhibiting low relative displacements were in areas of no liquefaction is not expected. The highest percentage (64%) of square manholes exhibiting high relative displacements was in areas of moderate to severe liquefaction. This is expected, as severe liquefaction is expected to be more damaging to structures in and above the ground. 24% of the manholes with the same high relative displacements were in areas of no liquefaction.

From the information presented in Figure 5, the reason for the reasonably high percentage (37%) of circular manholes with low relative displacement in areas of

moderate to severe liquefaction is the presence of a high water table (causing high severity of liquefaction) in combination with relatively shallow manhole embedment depths (Figure 4 a)). The shallow embedment depth limits the build-up of excess pore-water pressure acting on the base of the manhole. Circular manholes having high relative displacements while being in areas of no liquefaction (Figure 4 a)), is due to the embedment depth of the manhole being large, combined with a deep water table. A deep water table causes a thick, non-liquefiable crust that prevents (or limits the extent of) liquefaction establishing on the ground surface. The reason for 52% of square manholes showing low relative displacement in areas of moderate to severe liquefaction is due to a greater number of manholes being embedded at shallow depths (Figure 4 b)). Similar to the circular manholes, the 24% of square manholes with large relative displacements in areas of no liquefaction is due to the embedment depth of the manhole being large, combined with a deep water table. However, square manholes performed marginally better based on the higher percentage of manholes that exhibited low relative displacements situated in areas of moderate to severe liquefaction.

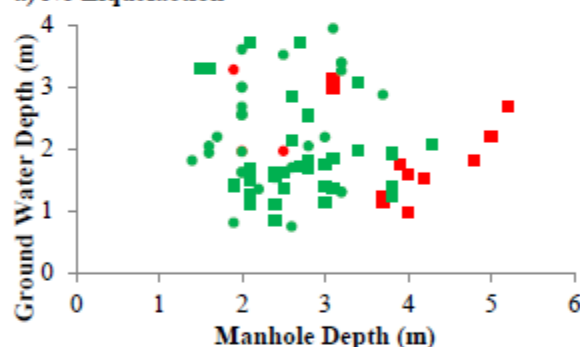
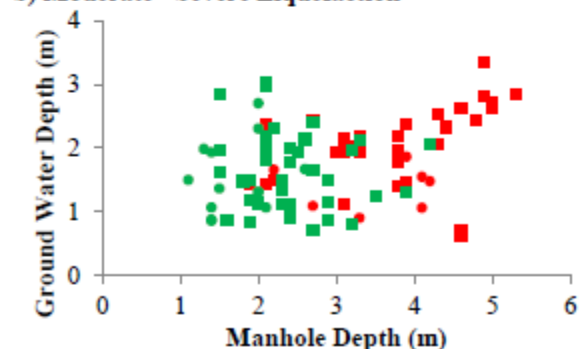
Groundwater depth information was obtained from Canterbury Geotechnical Database (2013) for the purposes of further explaining these trends. Figure 5 a) and b) show plots of groundwater depths against manhole depths for areas of no liquefaction and moderate to severe liquefaction respectively for square and circular manholes. For a constant ground water depth, an increasing manhole depth increases the relative displacement (Figure 5 a) and b)). There is clear indication that large relative displacement of manholes occurred for manhole depths > 3.0 m in areas of moderate to severe liquefaction. This is due to the excess pore water pressure acting on the base of the manhole being higher at greater depths below the water table. Both the water table depth and the manhole depth are key parameters controlling uplift of buoyant structures, and are two parameters investigated in the next section on parametric analyses.

Figure 5 a) and b): Plot of groundwater depth against manhole depth for areas of a) No liquefaction; and b) Moderate to severe liquefaction (both manhole types)

The reason for low relative displacements of square manholes is due to the heavier mass of the square manhole. Hence, square manholes are expected to uplift less in areas where moderate to severe liquefaction is prevalent. It should be noted that these conclusions have been made based on the limited sample size available, and significant uncertainty exists due to the highly variable ground conditions and spread of the different manhole shapes in the city.

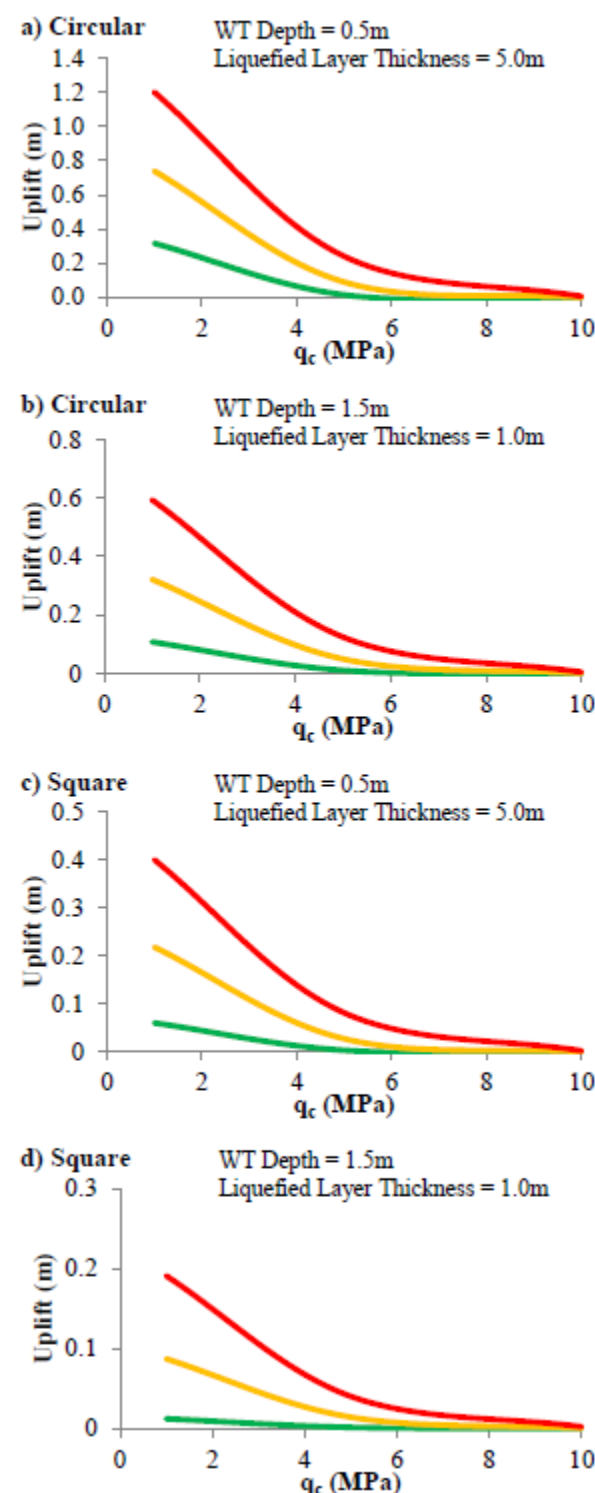
Simplified calculations of uplifts due to liquefaction based on the method of Sasaki and Tamura (2004) for circular and square manholes were carried out for varying depths of manholes, varying depths of water table, varying depths of liquefiable layers and varying penetration resistances. For simplicity, the peak ground accelerations were averaged for the three areas chosen. Figure 6 a) to 8d) show the results of the uplift analyses to give the uplift envelopes shown for a time (after liquefaction starts) of 30 seconds. This time was chosen as it is comparable to the time used in Sasaki and Tamura (2004) and based on engineering judgement. Square manholes, due to their heavier mass, are expected to exhibit smaller uplift than the lighter, circular manholes. There is a clear and steep increase in uplift for values of q_c less than 5 MPa, indicating this is one of the key parameters controlling uplift. Uplifts are small for $q_c > 5$ MPa; a higher value of q_c indicates the soil has a higher density and an increased resistance to liquefaction. The depth of the water table below the ground surface is also a key parameter controlling the uplift of manholes, when analysed together with manhole depth. When the manhole depth is held constant, shallow water table depths (0.5 m) caused greater uplifts compared to depths of about 1.5 m, due to a larger portion of the soil (in which the manhole is embedded) liquefying. Similarly, holding the water table depth constant but increasing the depth of the manhole results in higher calculated uplifts. For manhole depths of 3.5 m the uplifts are 4-6 times greater than manhole depths of 1.5 m. The observation that manhole depth and water table depth are key controlling parameters is consistent with the results of the correlations in the previous section. The thickness of the liquefied layer beneath the manhole controls the

amount of excess pore water pressure that can build up; a thicker layer causes higher pressures.

Figure 6 a) to d): Calculated uplifts for varying CPT Resistance, q_c , for a) and b) circular manholes; c) and d) square manholes
